### Local and innovative partnering in addressing large scale, chronic community water usage issues

Irrungadji – a small remote community in WA's Pilbara region

### Water consumption at Irrungadji

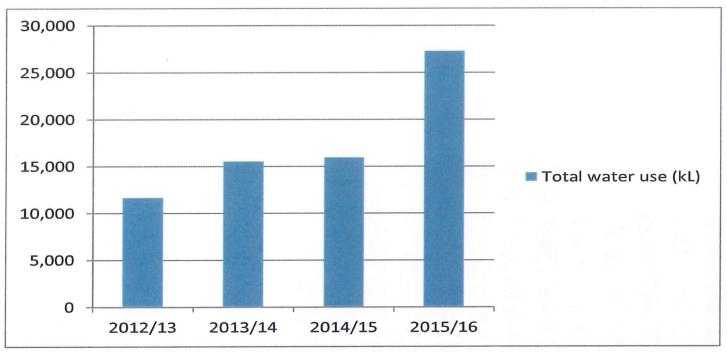
Figure 1: Historical water consumption at Irrungadji

- Data loggers confirm multiple major leaks some >20 litres/minute.
   Average community consumption was 87,312 litres/day.
- Escalating unsustainable levels of debt for water consumption (>\$100K)

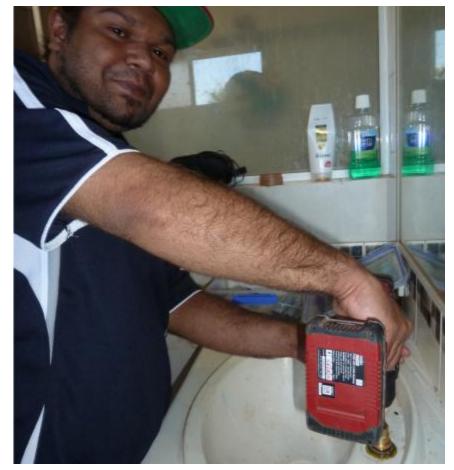
## Reseating a bathroom tap

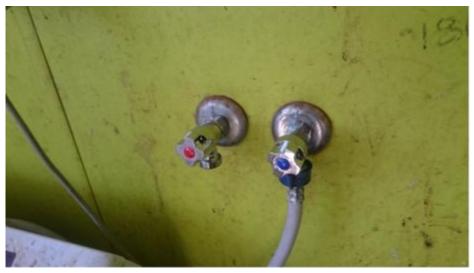
House 16 - leaking washing machine taps replaced

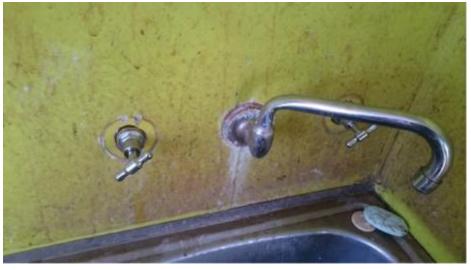
House 16 - leaking laundry taps reseated and spindles replaced

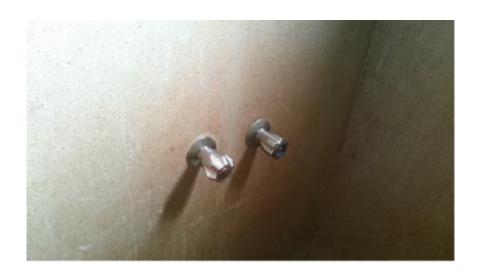
House 16 - shower tap spindle replaced (previously no handle)

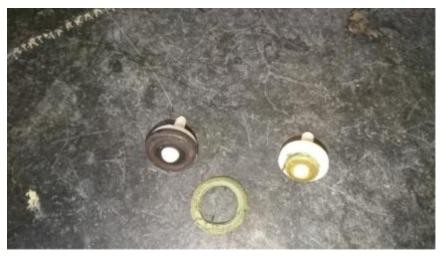
Washer on right from bath at house 16 - serious leak for considerable time- reseated and replaced by AEHW trainee

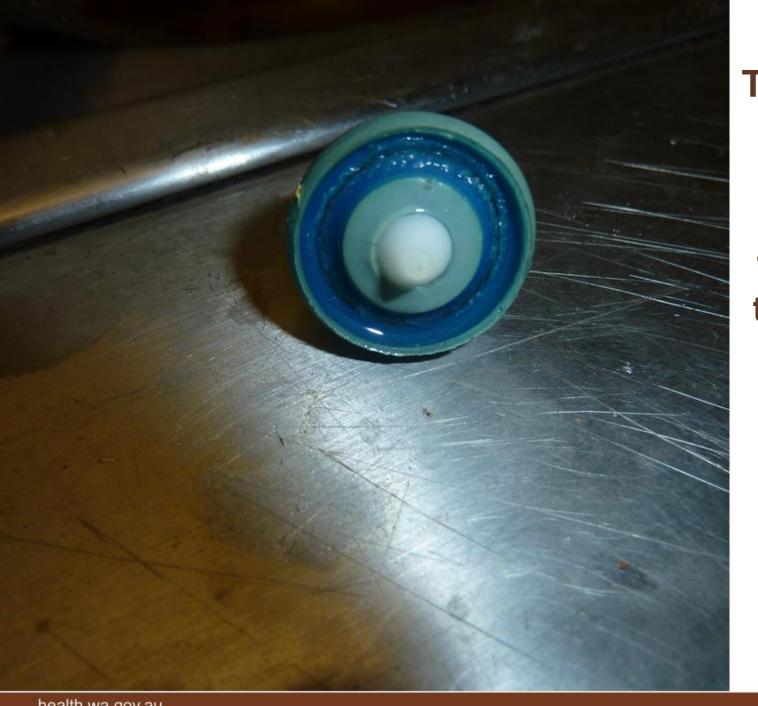
Tap washer distorted and damaged from over tightening to stop leak

New washer ~\$0.85

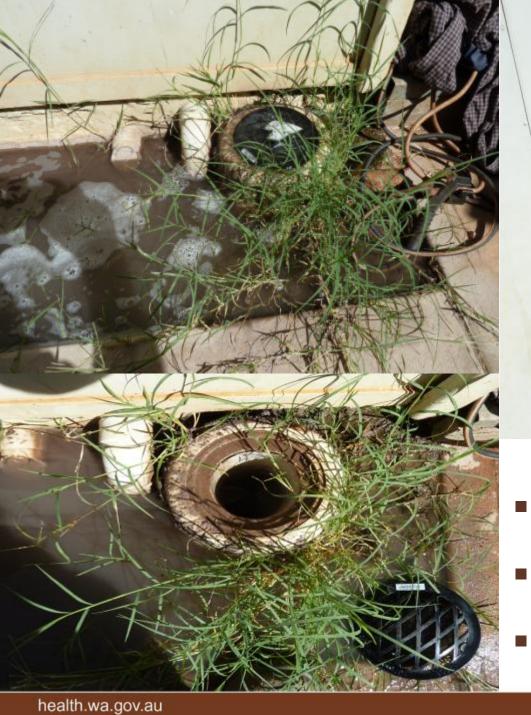
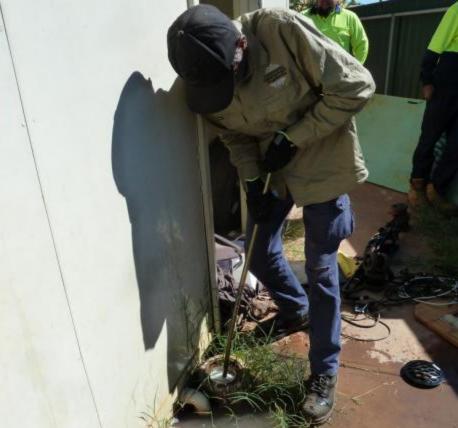
**Before (Blocked DT)**

**During**

After (Unblocked)

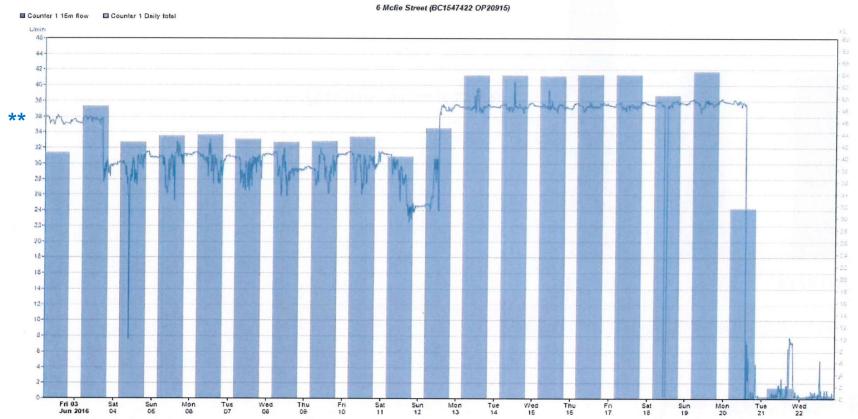
Figure 2: Data logger installed on House number 6 at Irrungadji Community.

# Example: daily water consumption figures (bars) for house 6 (21 day period)

<sup>\*\*</sup> Blue line shows flow rate during the 24 hour period of each day

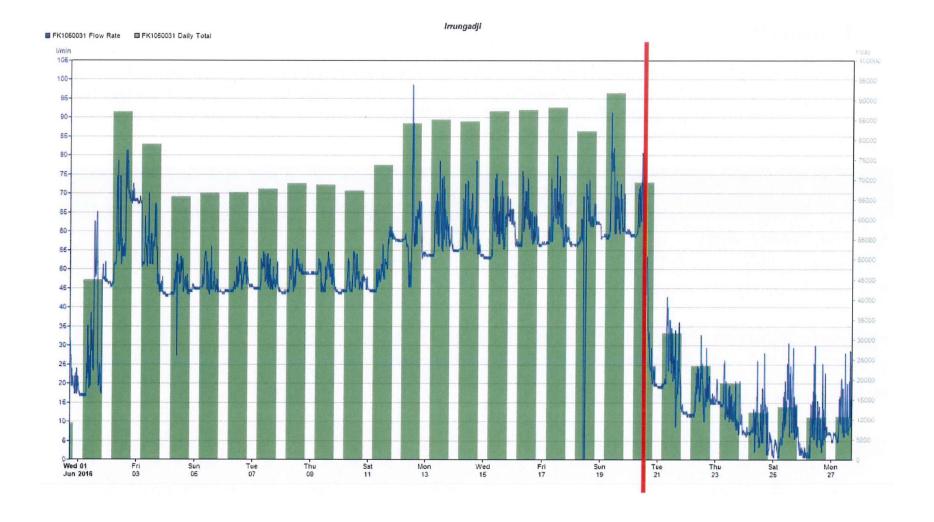
#### 76,000 litres/day reduction ~ 90% reduction

## Daily water use and flow rate before & after plumbing repairs (indicated by red line)

Before	After
Overall Water Use		
Average Daily Use (L/day)	87,312	10,672
Maximum Daily Use (L/day)	160,000	16,000
Minimum Daily Use (L/day)	30,000	10,000
Sites with leak identified		
Number of Sites with major leaks (>3L/minute	5	0
Average Leak (L/minute)	20L/minute	0
